CALSPAN ON-SITE VEHICLE DEFECT INVESTIGATION

CALSPAN CASE NO. 92-5

VEHICLE - 1992 FORD AEROSTAR XL MINIVAN

# **TECHNICAL REPORT STANDARD TITLE PAGE**

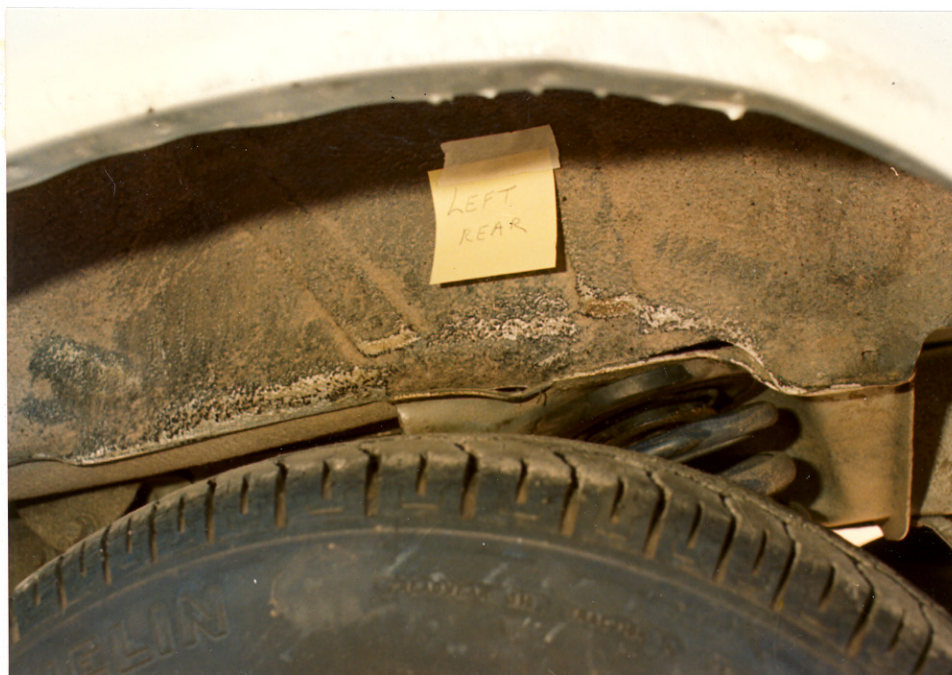
The roll pin fractured which allowed the stud to separate from the control arm and fall from the vehicle. As a result, the rear axle was free to move laterally, thus producing lateral instability in the vehicle. The rear tires subsequently contacted the inner aspects of the wheel openings, which abraded the undercoating from the sheetmetal and deformed the inboard edges of the inner wheel openings. The tires also contacted the rear coil springs which were jacketed by vinyl (top 4 coils). The left rear tire scuffed the left coil spring jacket while the right rear tire

Tire Abrasions To The Inner Wall Of The Left Rear Wheel Housing.

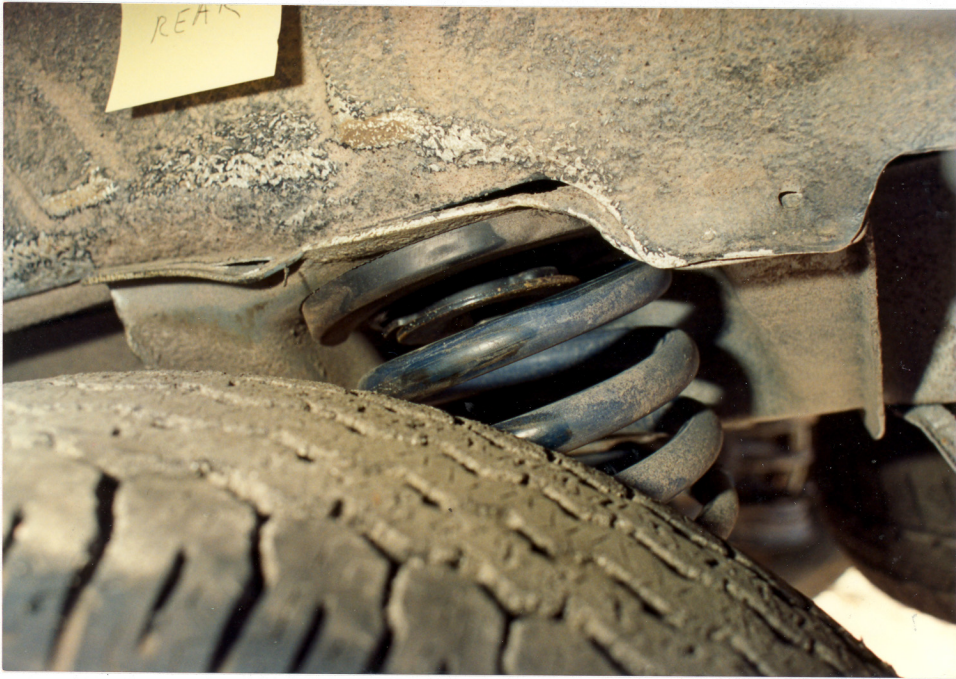
Tire Abrasions To The Vinyl Jacket On The Left Rear Coil Spring.

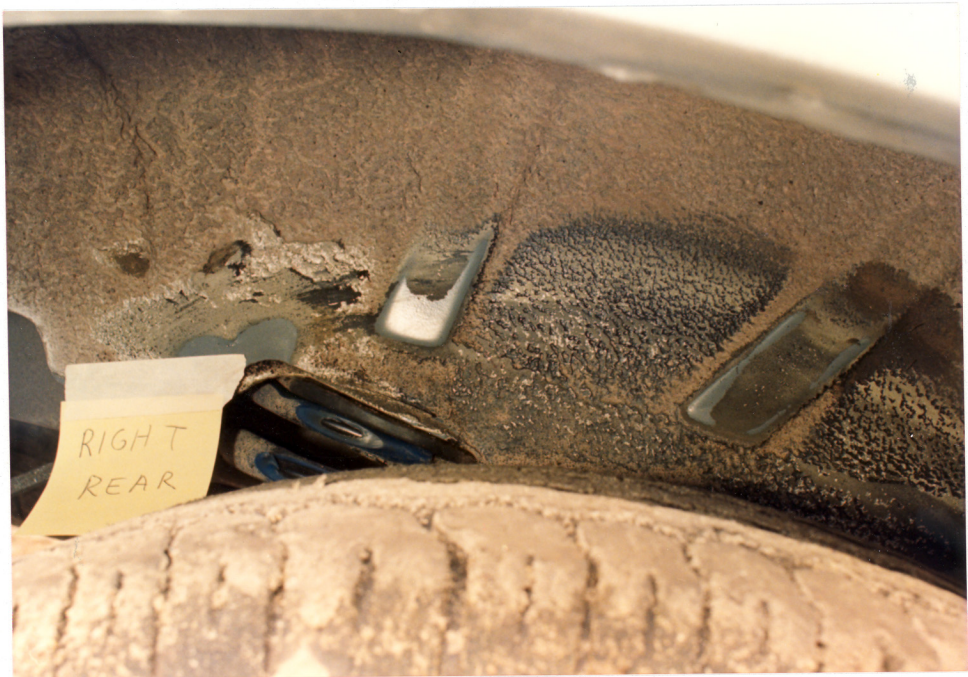
Tire Abrasions To The Right Rear Inner Wheel Housing.

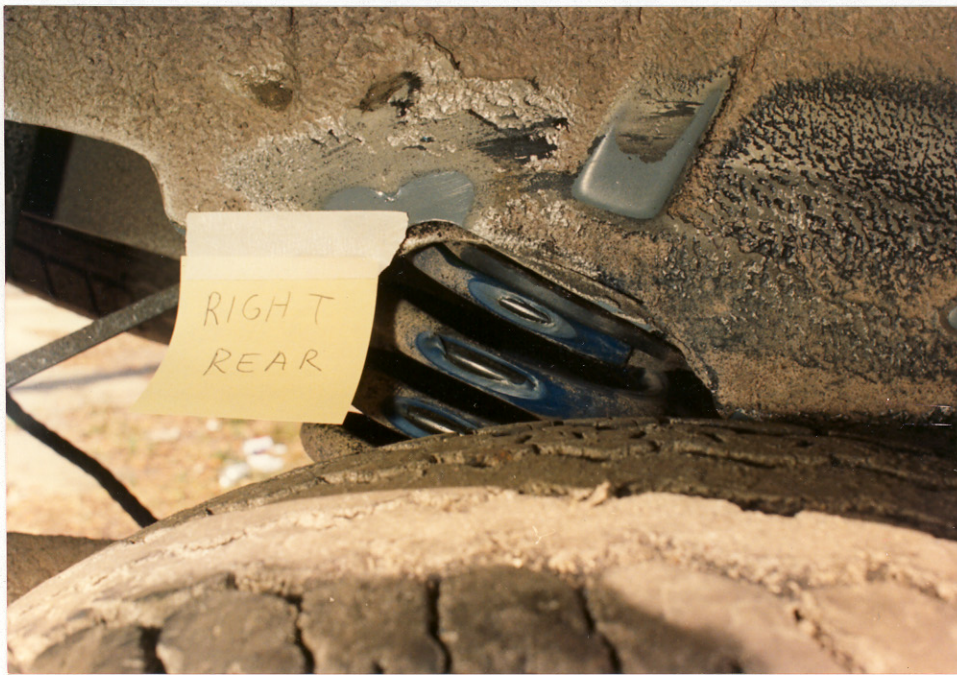
rubbed through the right vinyl spring covering. The abrasions to the coil spring coverings occurred as the wheels were rotating and the axle was shifting from side-to-side. The stud end of the upper control arm impacted the frame mounting bracket numerous times during the axle shift which produced circular gouges to the bracket.

Tire Abraded Jacket Of The Right Rear Coil Spring.

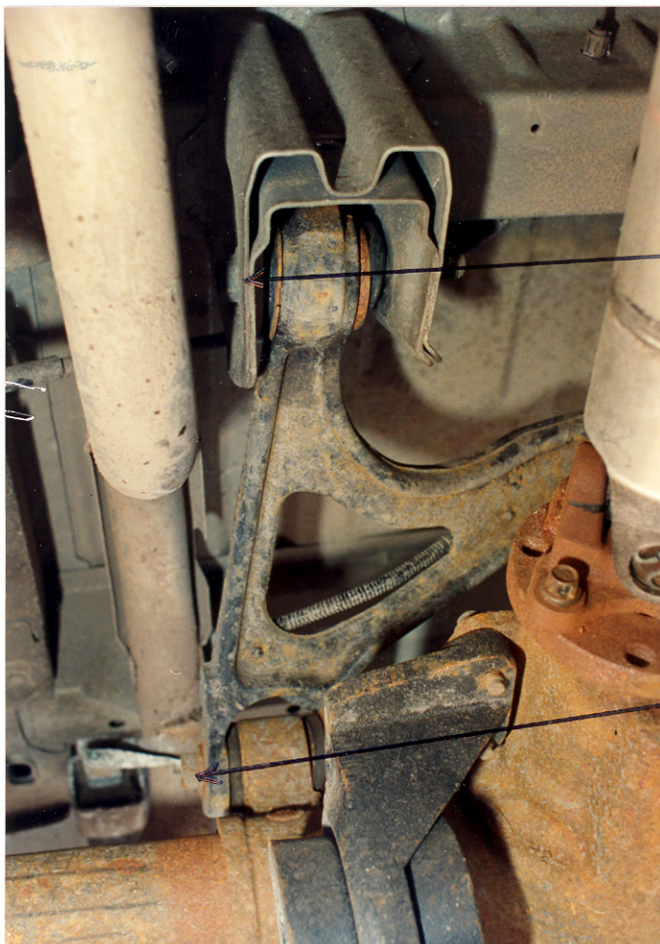
The rear bolt on the control arm required 150 ft. lbs. of torque to loosen the nut while the front mounted bolt and nut assembly required approximately 140 ft. lbs. of torque to loosen the nut. Torques were obtained from a one-half inch drive MAC tools torque wrench with a model number of [REDACTED].

Forward Bolt  
Torqued At 140 Ft.Lbs.

Rear Axle Mounted Bolt  
Torqued At 150 Ft.Lbs.

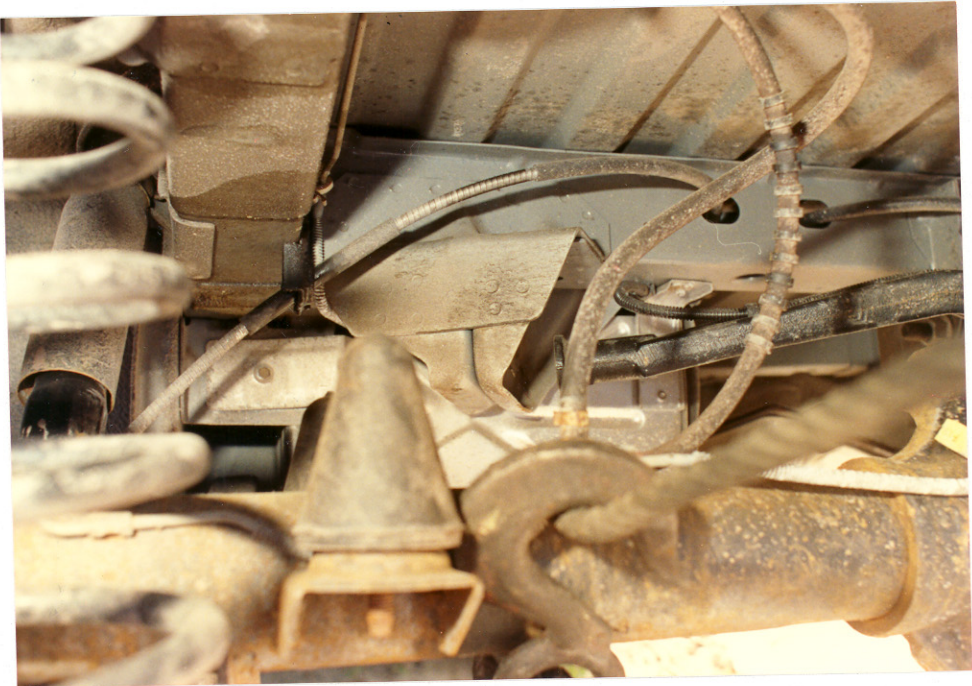
Separated Lateral Mount Of The Upper Control Arm.

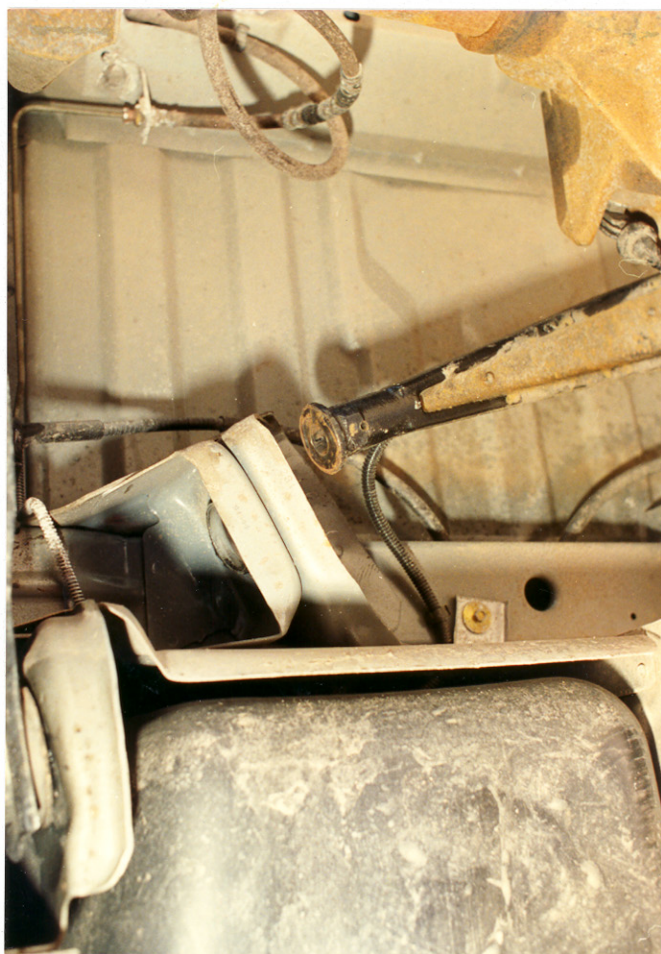
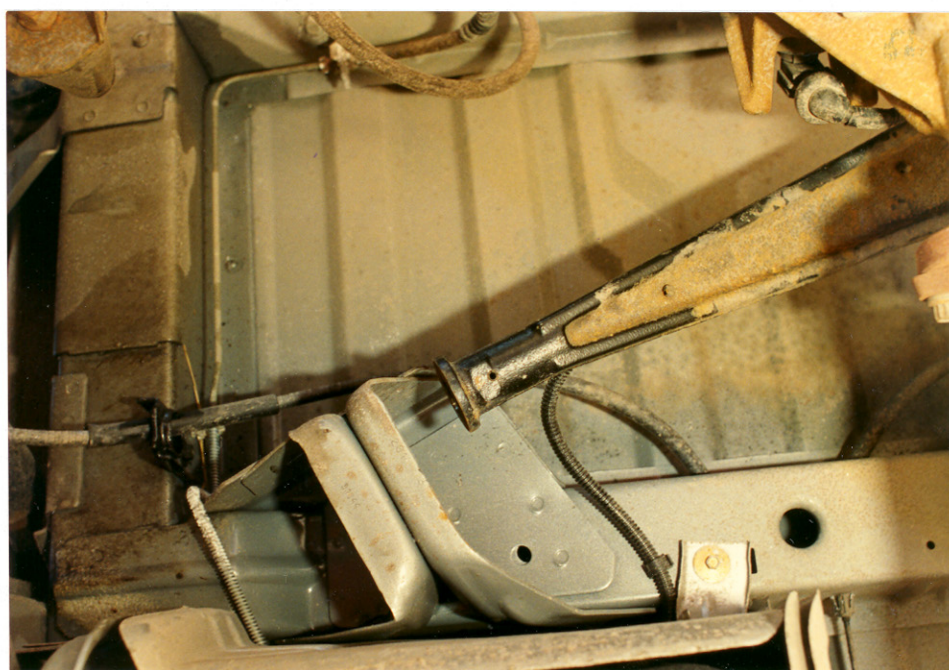
Separated Lateral Mounting Point Of The Rear Upper Control Arm.

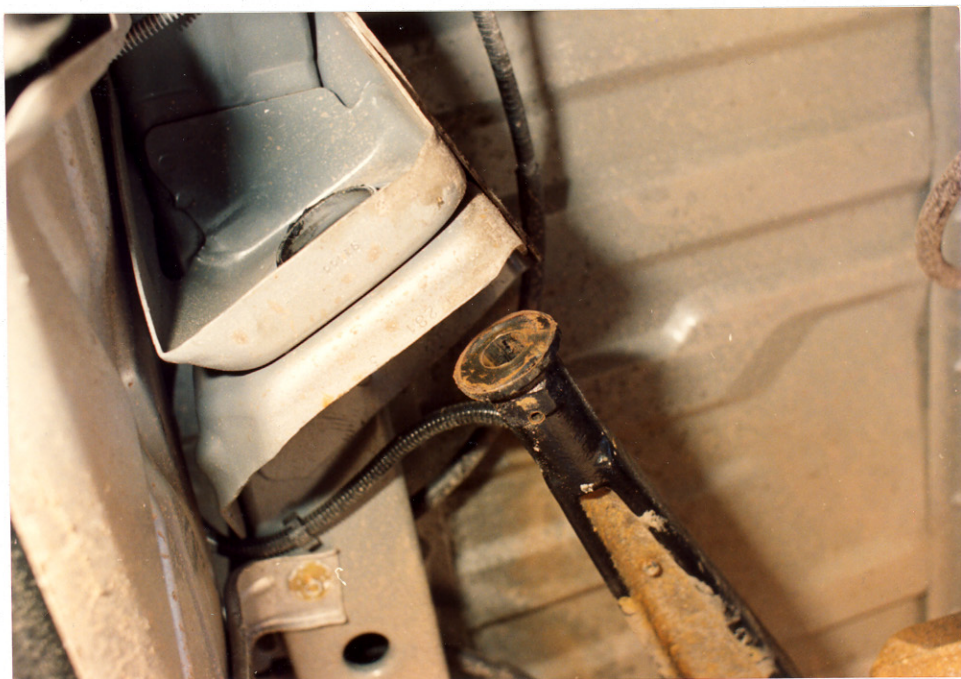
Closeup View Of The Stud Bore And Fractured 3/16" Diameter Roll Pin.

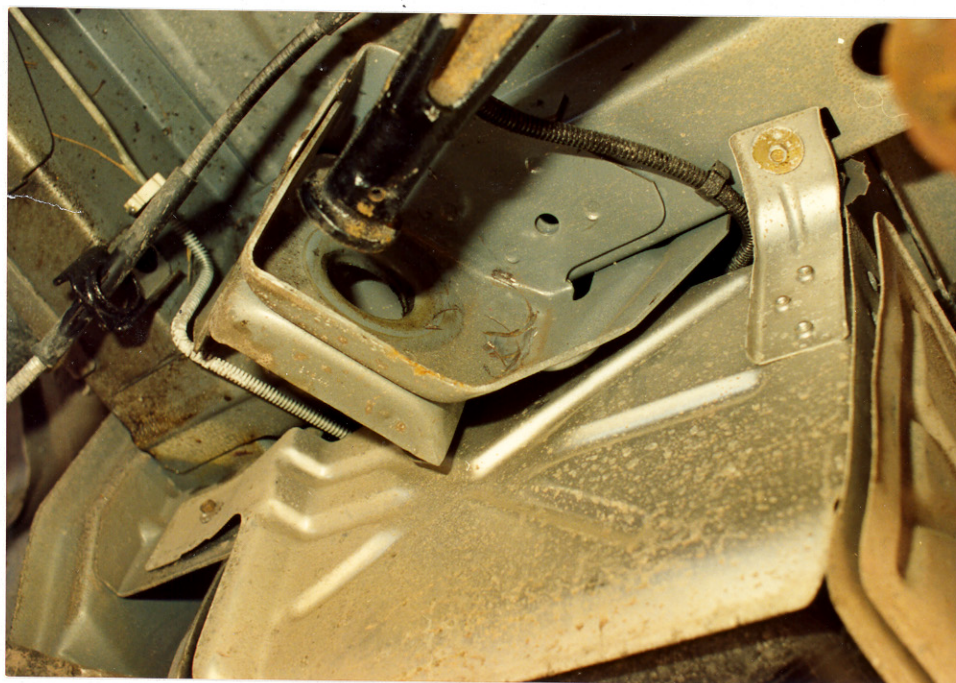
Control Arm Gouged The Lateral Mounting Bracket.

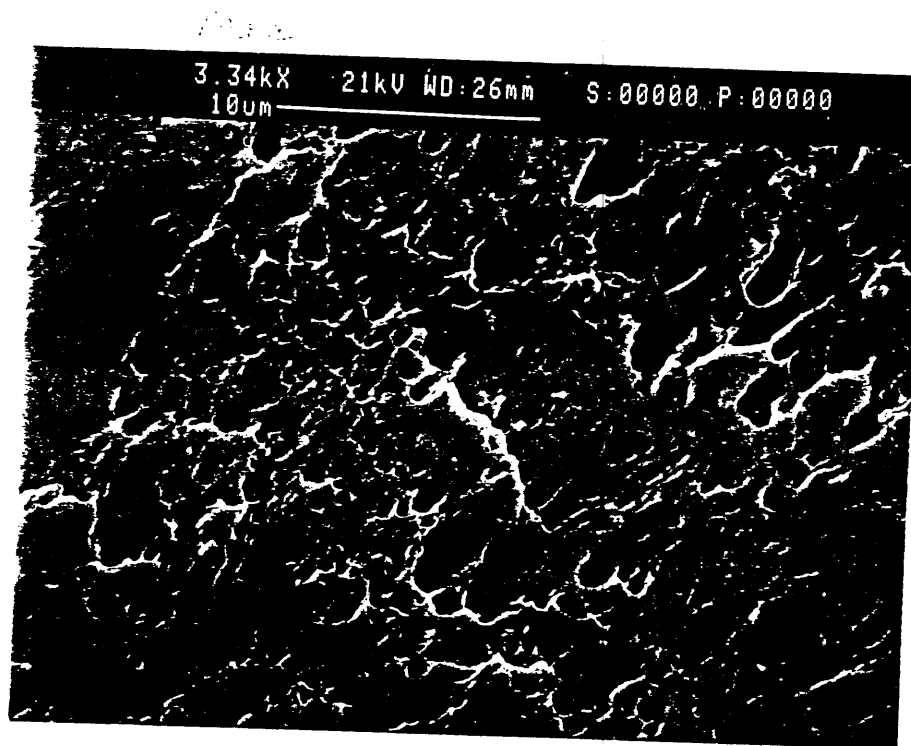
**CONCLUSIONS:** Based upon a metallurgical review of the failed rear upper control arm, the roll pin pieces appear to have failed due to ductile overstress.

*Overstress Region*

FIGURE 10: Top roll pin piece at  
a magnification of up  
to 3340X
